New Hampshire Volunteer Lake Assessment Program

2003 Interim Report for Loon Lake Plymouth

Loon Lake, Plymouth

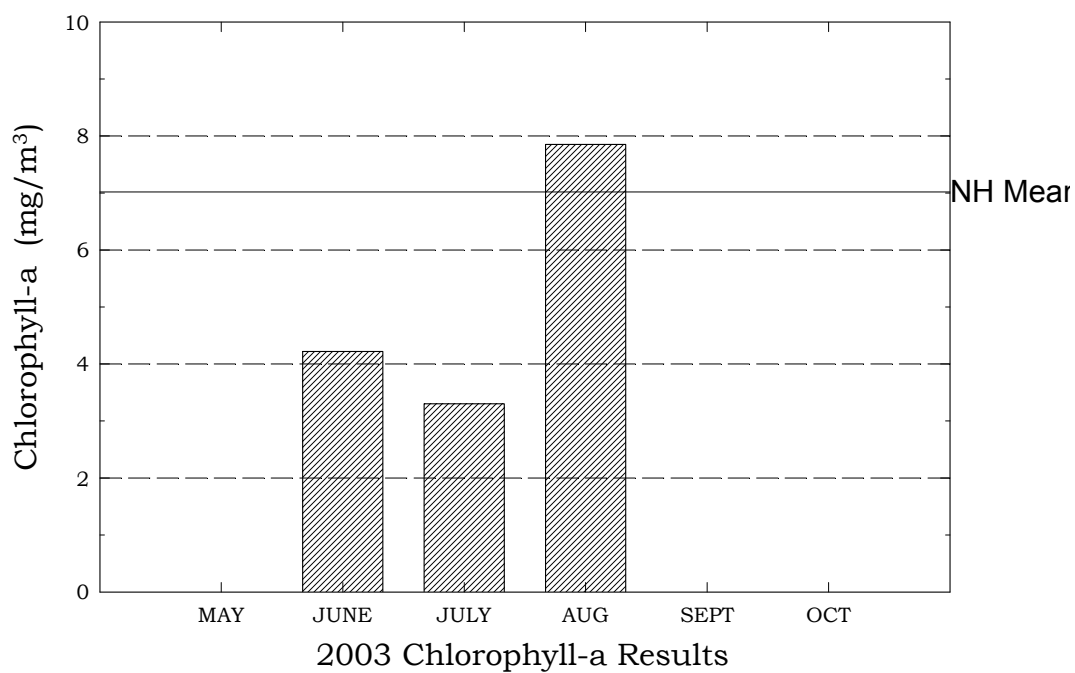
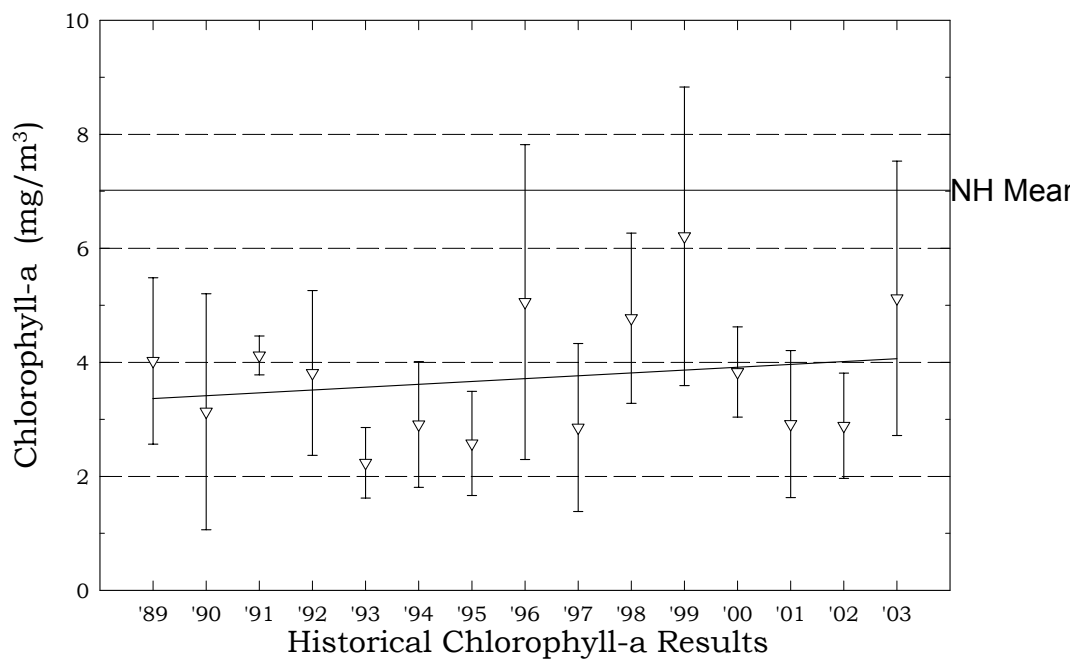
Figure 1. Monthly and Historical Chlorophyll-a Results

- **Figure 1 and Table 1:** The graphs in Figure 1 (Appendix A) show the historical and current year chlorophyll-a concentration in the water column. Table 1 (Appendix B) lists the maximum, minimum, and mean concentration for each sampling season that the lake/pond has been monitored through the program.

The current year data (the top graph) show that the chlorophyll-a concentration **decreased** from June to July, and then **increased** from July to August. The chlorophyll-a concentration in August was **greater than** the state mean.

The historical data (the bottom graph) show that the 2003 chlorophyll-a mean is **less than** the state mean.

Overall, visual inspection of the historical data trend line (the bottom graph) shows a **variable** in-lake chlorophyll-a trend, meaning that the concentration has **fluctuated, but has not continually increased or decreased**, since monitoring began in 1989. In the 2004 annual report, we will conduct a statistical analysis of the historic data to objectively determine if there has been a significant change in the annual mean chlorophyll-a concentration since monitoring began.

While algae are naturally present in all lakes/ponds, an excessive or increasing amount of any type is not welcomed. In freshwater lakes/ponds, phosphorus is the nutrient that algae depend upon for growth. Algal concentrations may increase with an increase in nonpoint sources of phosphorus loading from the watershed, or in-lake sources of phosphorus loading (such as phosphorus releases from the sediments). Therefore, it is extremely important for volunteer monitors to continually educate residents about how activities within the watershed can affect phosphorus loading and lake/pond quality.

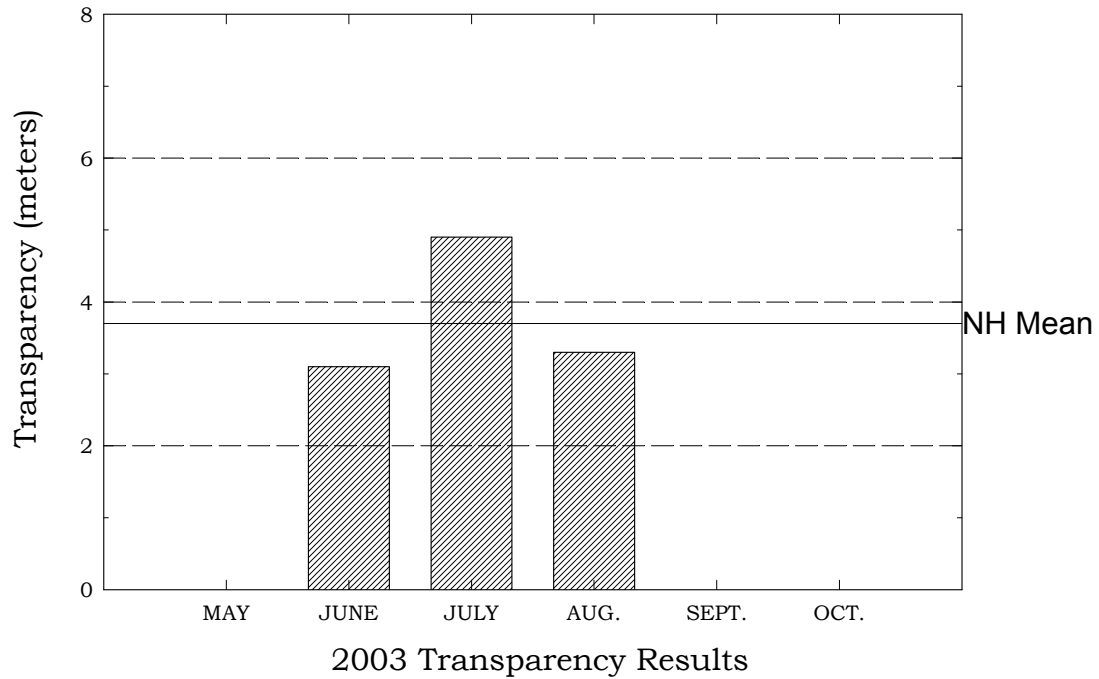
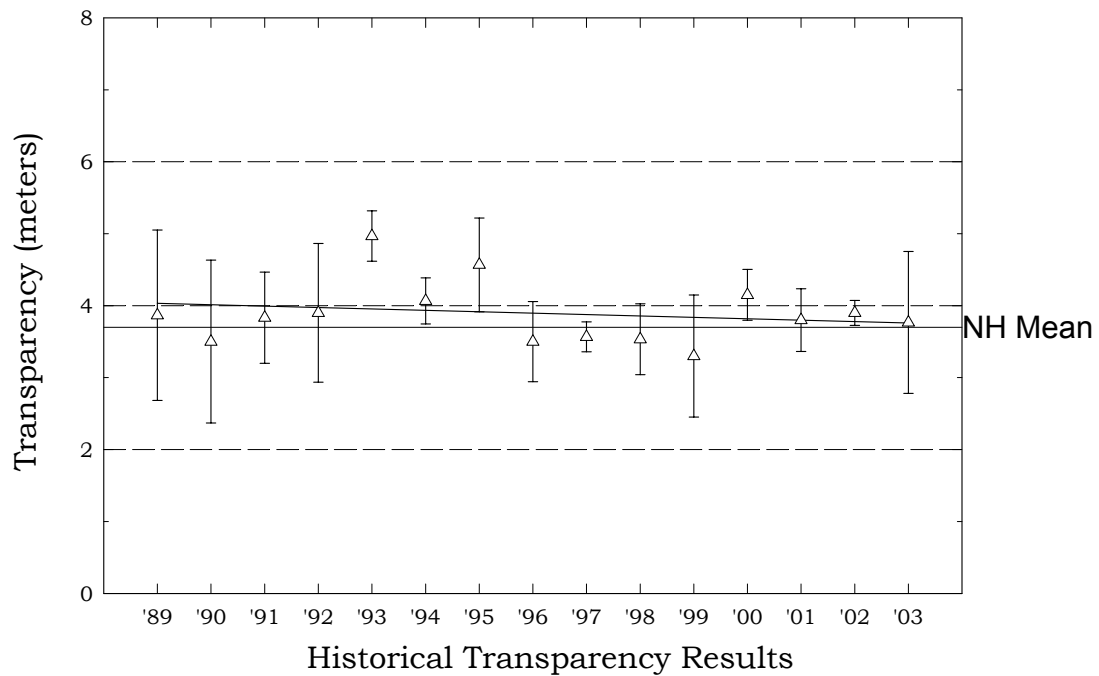
Figure 2. Monthly and Historical Transparency Results

- **Figure 2 and Table 3:** The graphs in Figure 2 (Appendix A) show historical and current year data for lake/pond transparency. Table 3 (Appendix B) lists the maximum, minimum and mean transparency data for each sampling season that the lake/pond has been monitored through the program.

The current year data (the top graph) show that the in-lake transparency **increased** from June to July, and then **decreased** from July to August. The transparency in July was **greater than** state mean.

The historical data (the bottom graph) show that the 2003 mean transparency is **approximately equal to** the state mean.

Overall, visual inspection of the historical data trend line (the bottom graph) shows a **relatively stable** trend for in-lake transparency, meaning that the transparency has **remained approximately equal to the state mean** since monitoring began. As discussed previously, in the 2004 annual report we will conduct a statistical analysis of the historic data to objectively determine if there has been a significant change in the annual mean transparency since monitoring began.

Typically, high intensity rainfall causes erosion of sediments into lakes/ponds and streams, thus decreasing clarity. Efforts should continually be made to stabilize stream banks, lake/pond shorelines, disturbed soils within the watershed, and especially dirt roads located immediately adjacent to the edge of tributaries and the lake/pond.

Guides to Best Management Practices designed to reduce, and possibly even eliminate, nonpoint source pollutants, such as sediment loading, are available from DES upon request.

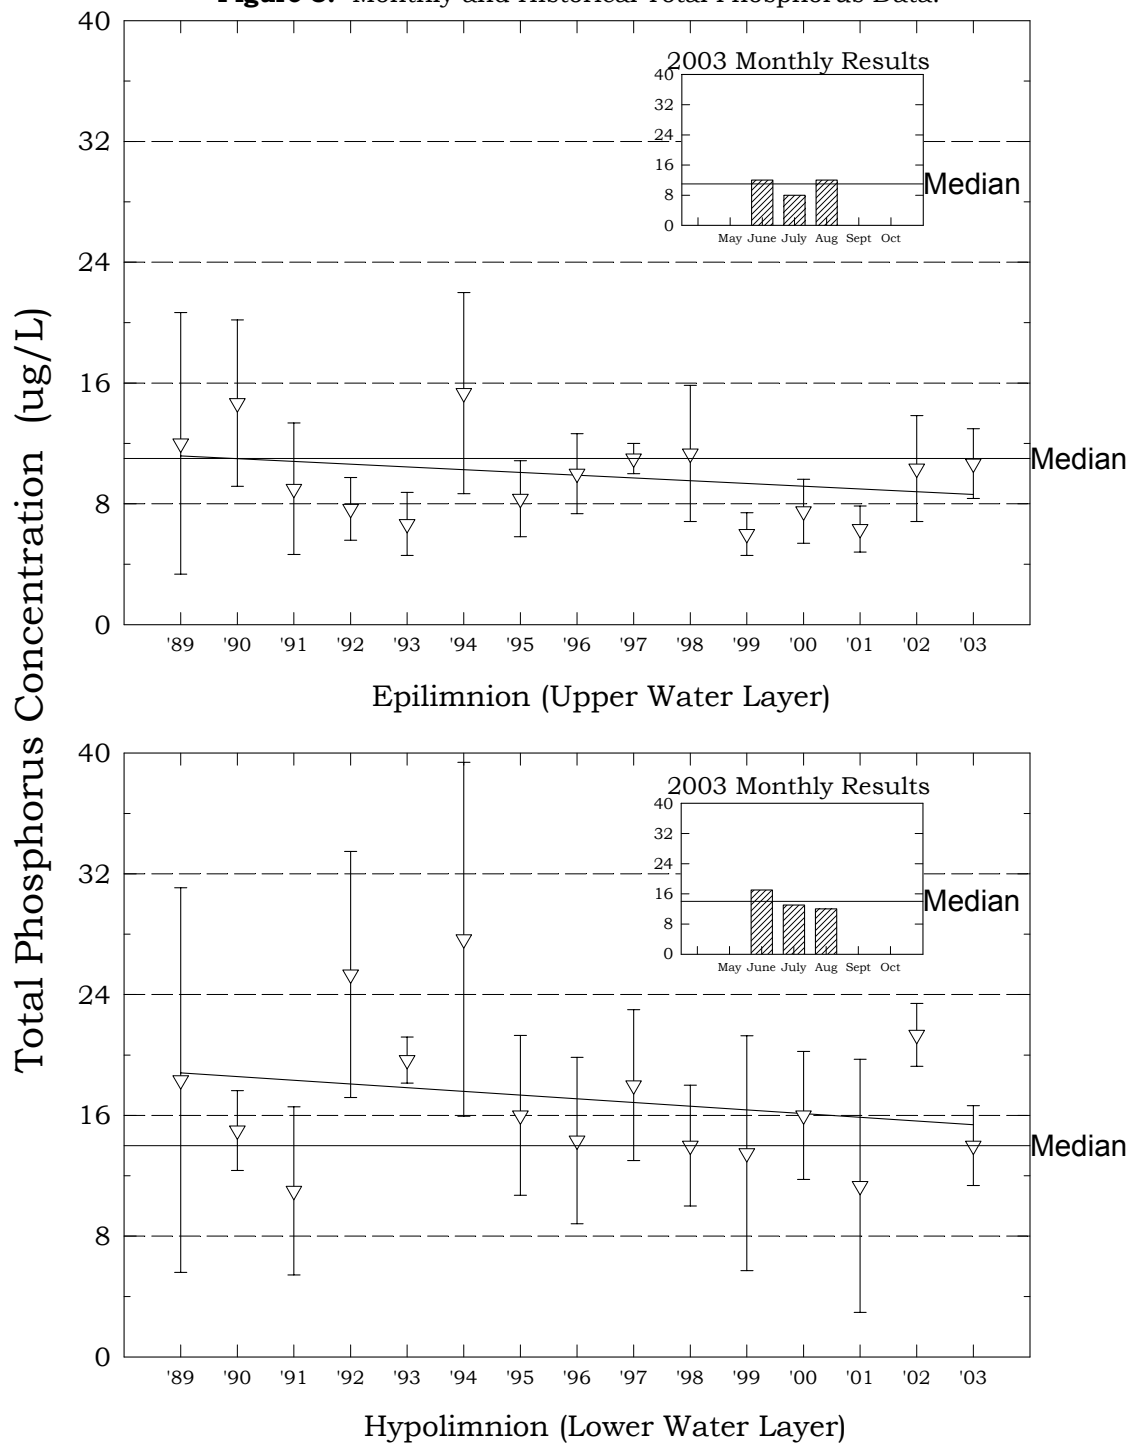
Figure 3. Monthly and Historical Total Phosphorus Data.

- **Figure 3 and Table 8:** The graphs in Figure 3 (Appendix A) show the amounts of phosphorus in the epilimnion (the upper layer) and the hypolimnion (the lower layer); the inset graphs show current year data. Table 8 (Appendix B) lists the annual maximum, minimum, and median concentration for each deep spot layer and each tributary since the lake/pond has joined the program.

The current year data for the epilimnion (the top inset graph) show that the phosphorus concentration **decreased** from June to July, and then **increased** from July to August. The phosphorus concentration in June and August was **slightly greater than** the state median.

The current year data for the hypolimnion (the bottom inset graph) show that the phosphorus concentration **decreased** from June to August. The phosphorus concentration in June was **slightly greater than** the state median.

The historical data show that the 2003 mean epilimnetic and hypolimnetic phosphorus concentration is **approximately equal to** the state median.

Overall, visual inspection of the historical data trend line for the epilimnion and the hypolimnion show **a variable, but overall decreasing (meaning improving)**, phosphorus trend since monitoring began in 1989.

One of the most important approaches to reducing phosphorus loading to a waterbody is to continually educate watershed residents about its sources and how excessive amounts can adversely impact the ecology and value of lakes and ponds. Phosphorus sources within a lake or pond's watershed typically include septic systems, animal waste, lawn fertilizer, road and construction erosion, and natural wetlands.
